Current State of Infrastructure Maintenance and Monitoring in Taiwan

(ACECC TC-28, CECAR9, 22nd of Sep 2022)

Prof. Tzu-Kang Lin, Chair

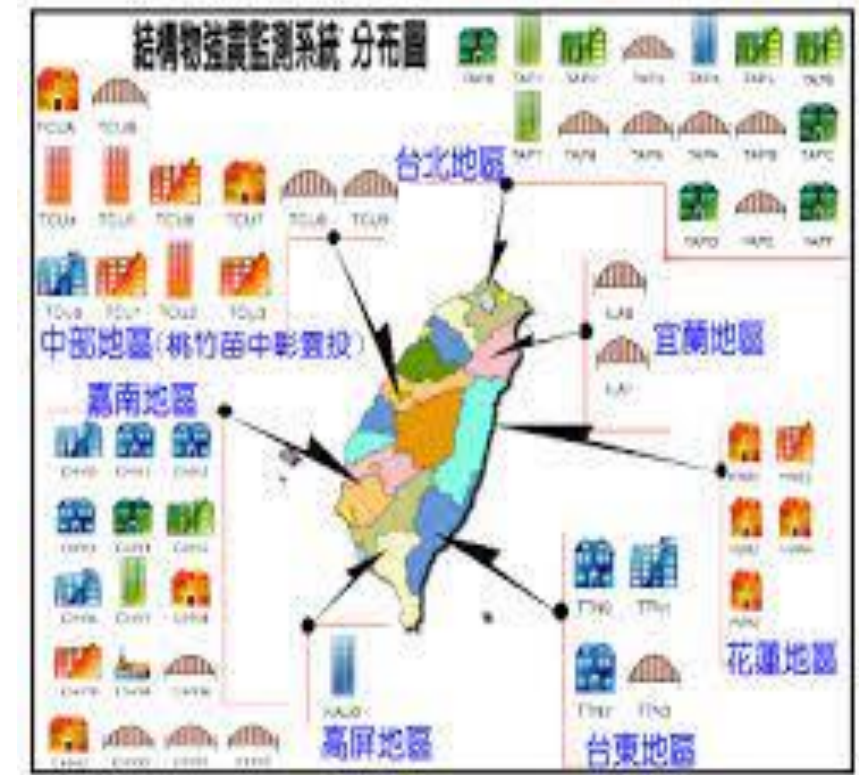
- More than 40 infrastructures (building and bridge) are monitored by the **Central Weather Bureau** supported by the Taiwan government
- Basic information: structure introduction 、 sensor layout and description
- Monitoring database: seismic event(before^{2min} 、 earthquake^{2min} 、 after^{2min}) 、 whole duration (local/30days)

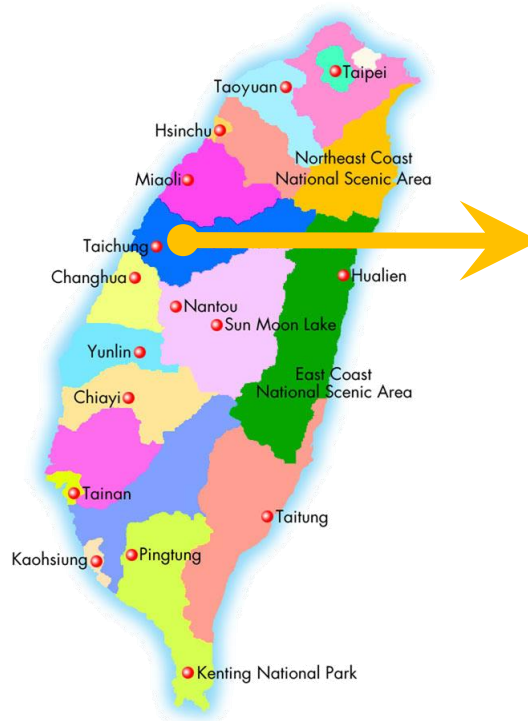
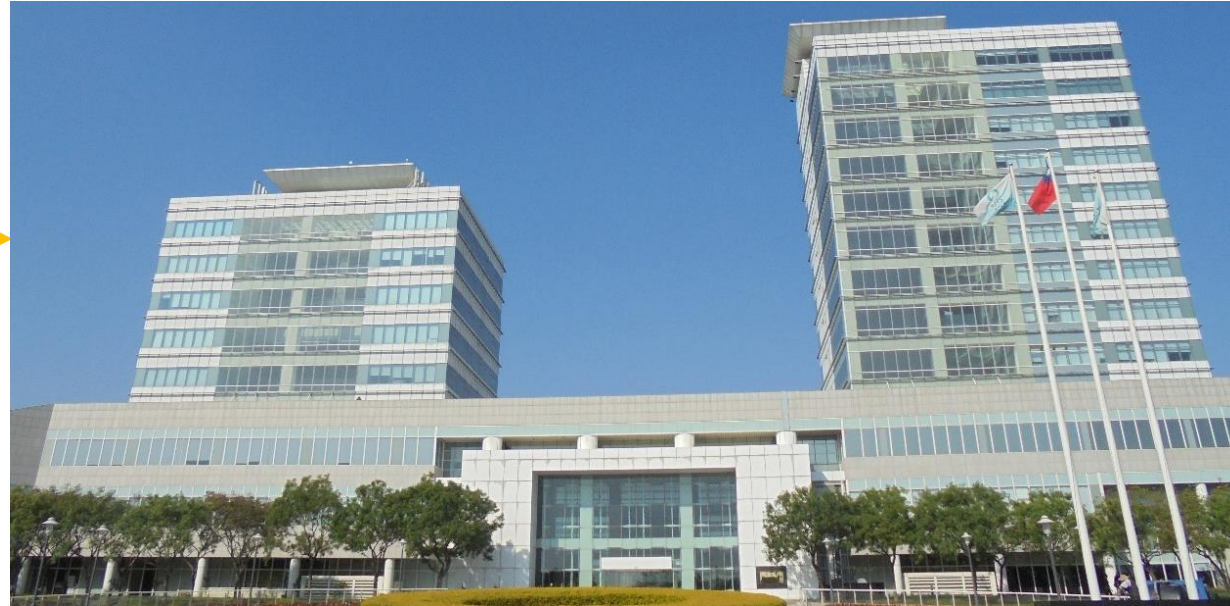
CTSPB Building and IC Building

Industrial & Commercial (IC) Building

41 m in height (9F)

Central Taiwan Science Park Bureau (CTSPB) Building

58 m in height (13F)

2 underground stories and the lowest 3 overground stories are connected by a **common RC structure**

- Both office buildings locate in Central Taiwan Science Park at Taichung and are **steel framed structures**.

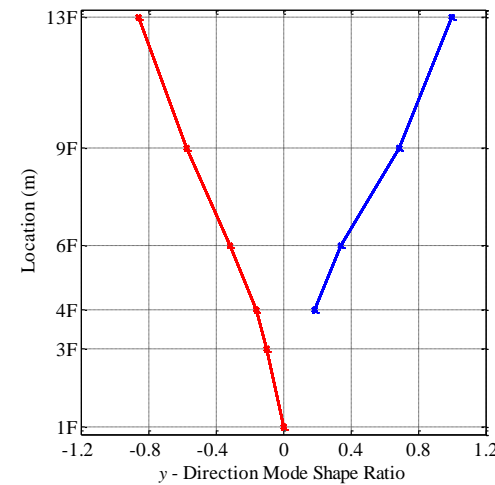
Mode T1:
0.948 Hz; 1.25%

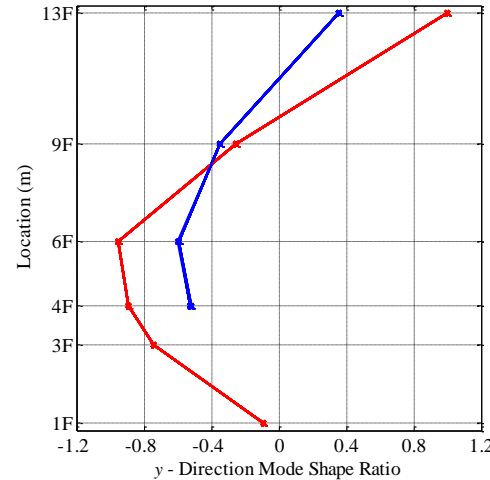
Mode B2-1:
1.966 Hz; 1.17%

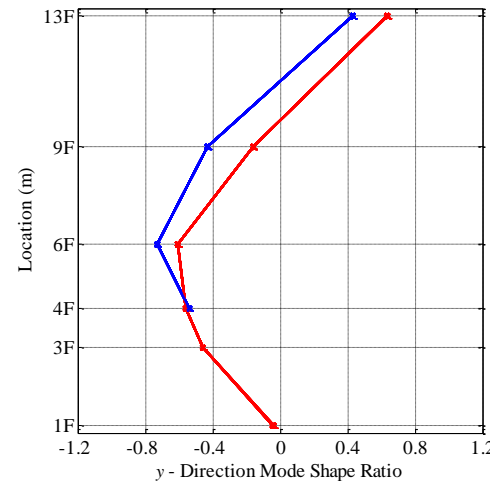
Mode B2-2:
2.022 Hz; 1.43%

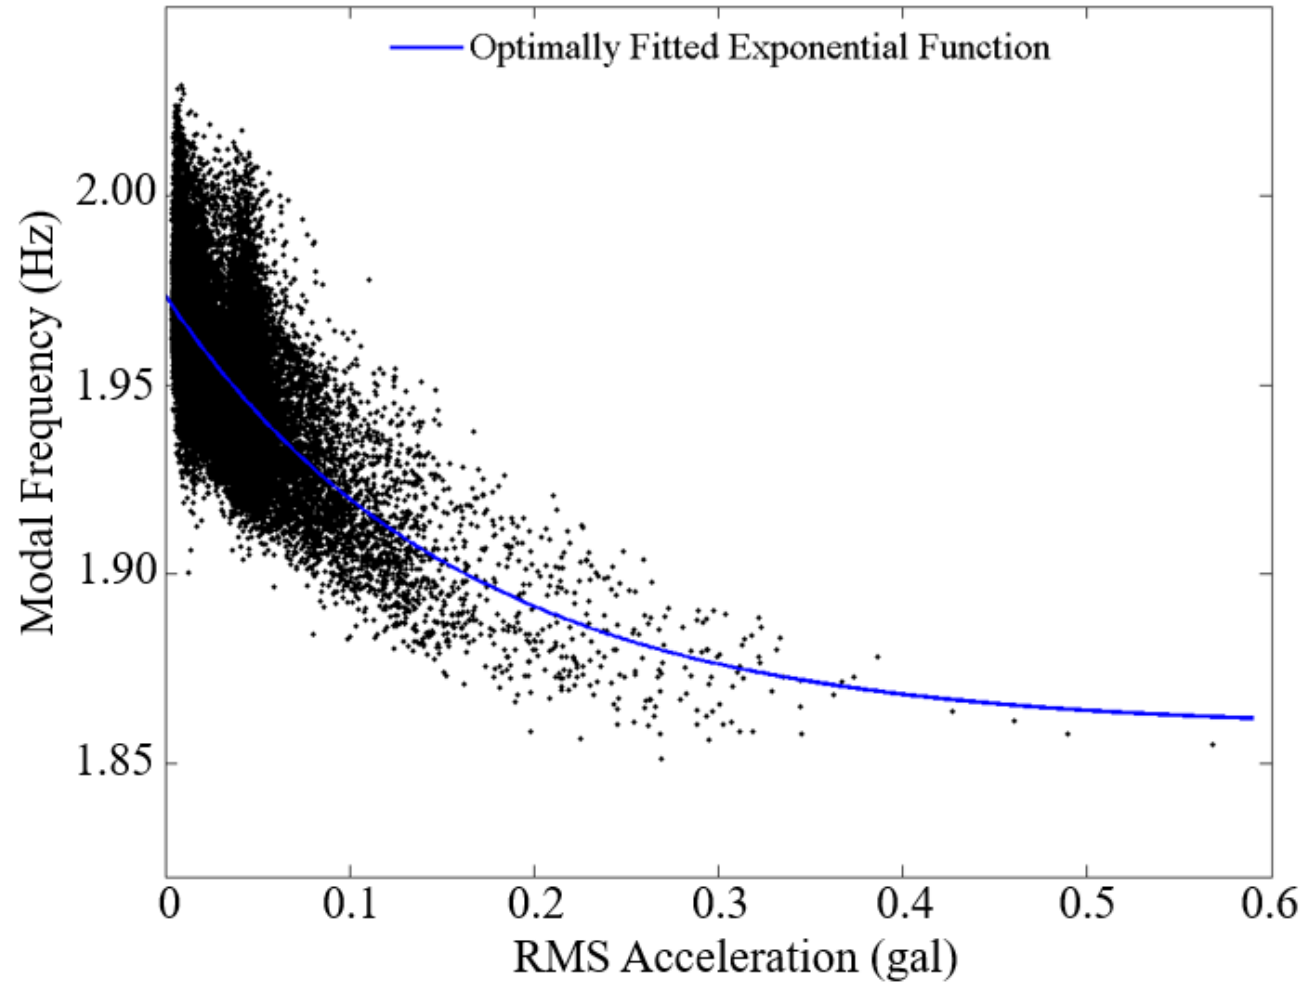
Mode B2-1 Frequency vs. RMS Acceleration

CTSPB Building

- The significant effect of the RMS response on the modal parameters can be reasonably explained by considering the possible **relaxation of boundary conditions and contact conditions** between structural members under **large responses**.
- The modal frequencies are decreased by the **reduction in stiffness** and **increase** the **damping ratios** by the enhanced energy dissipation.

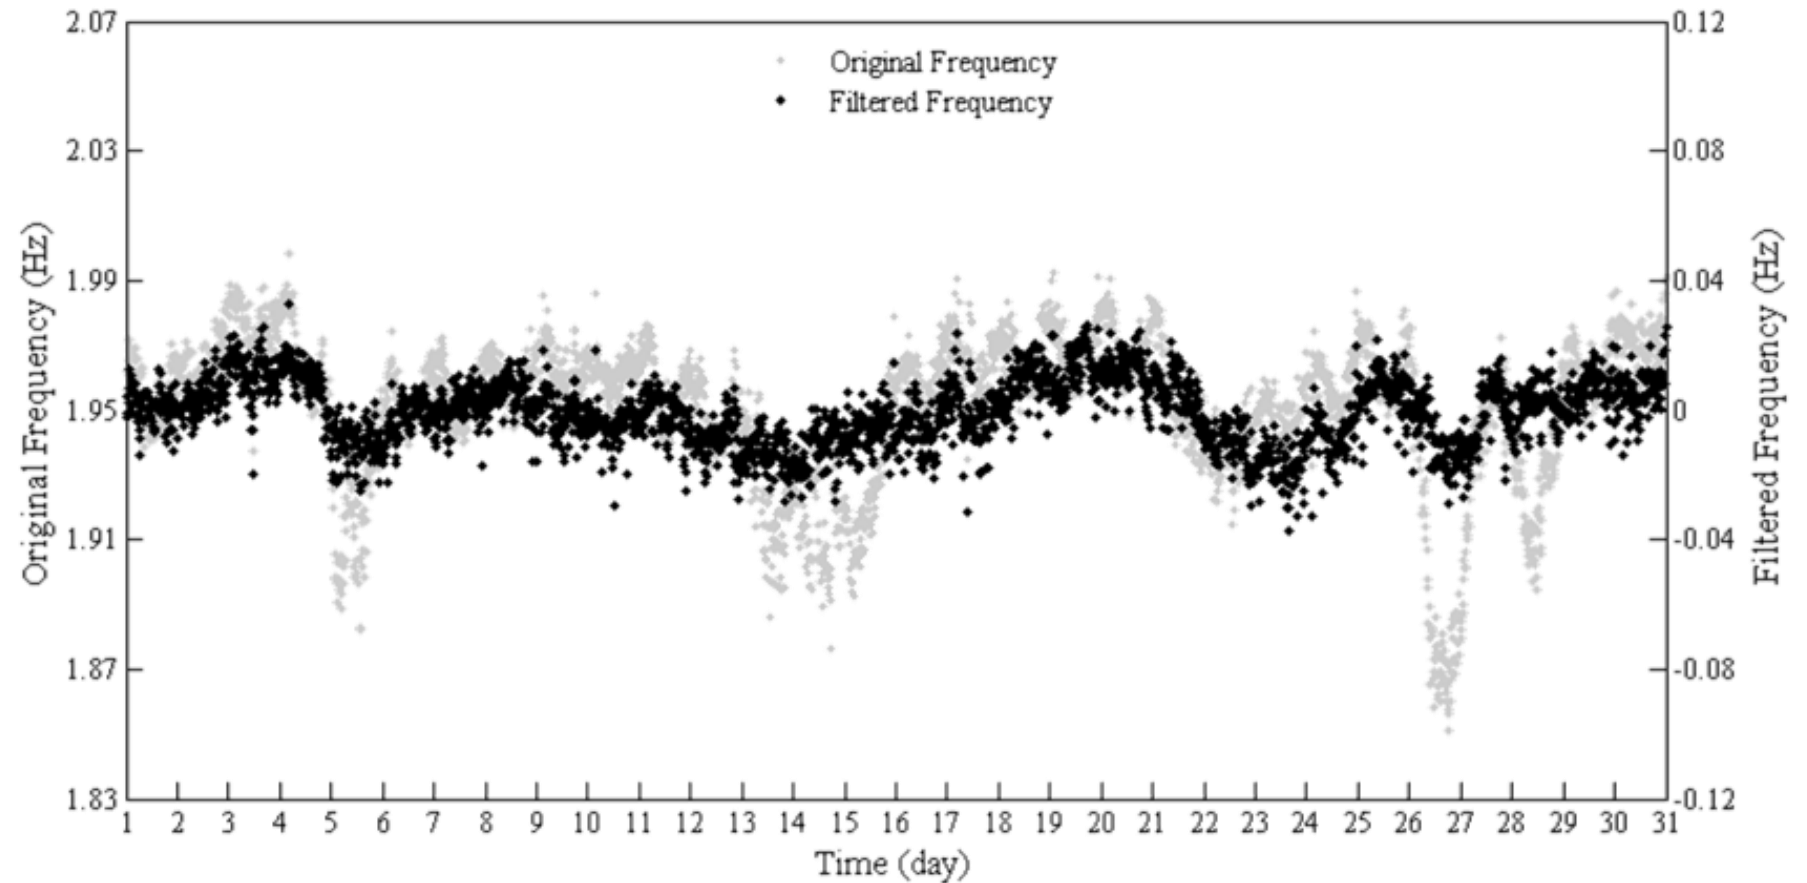
Mode B2-1 of
CTSPB Building
(2016/12)

Elimination of Environmental Effects
